Monitoring Data Record

Project Title: U-2524AB Site 28 COE Action ID: 200321137
 Stream Name: UT to Hickory Creek DWQ Number: 030909
 City, County and other Location Information: Greensboro Western Loop, Guilford Co.
Sta. 29+00 to 32+00 – 40 SB REV-

Date Construction Completed: Water was turned into the stream on July 2005 and planted February 2006. Monitoring Year: (2) of 5

Year 2 Winter – February 2007

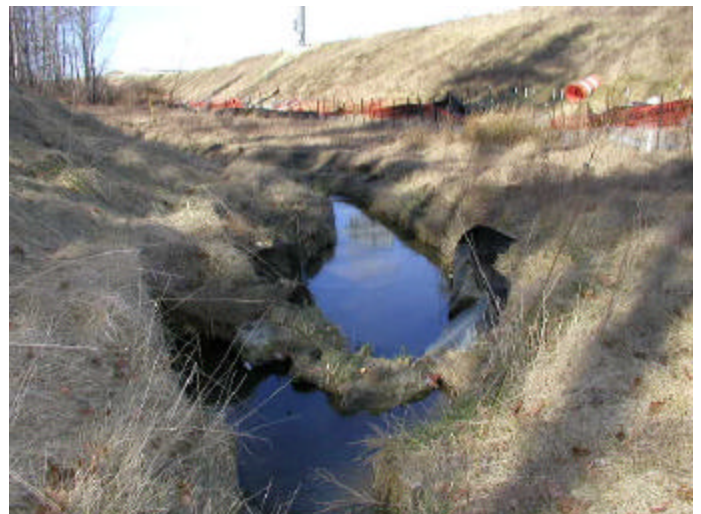
Photo Point #6 (Downstream)

This is the Year 2 winter evaluation for this stream relocation. The channel is stable except for the headcut and erosion around a crossvane at approx. Sta. 30+00 –40 SB REV- (Photo Point #6 Downstream) that was noted during the last monitoring visit. The crossvane is scheduled to be repaired. The area where water was piping under ground and bypassing a bend in the stream (Photo Point #8 Upstream) noted last monitoring visit is now functioning properly. There is no corrective action needed in this area. NCDOT will continue to monitor this stream relocation.

Date Inspected	Sta. 30+00 – 40SBREV-	Station Number	Station Number	Station Number	Station Number
Structure Type	Crossvane				
Is water piping through or around structure?					
Head cut or down cut present?	Headcut				
Bank or scour erosion present?
